CASE STUDY

**PROFIBUS network failure
resolution and maintenance
for one of the biggest
brewery manufacturer in the
world**

PROFIBUS network failure resolution and maintenance for one of the biggest brewery manufacturer in the world

Client: AB InBev, Mysore, India

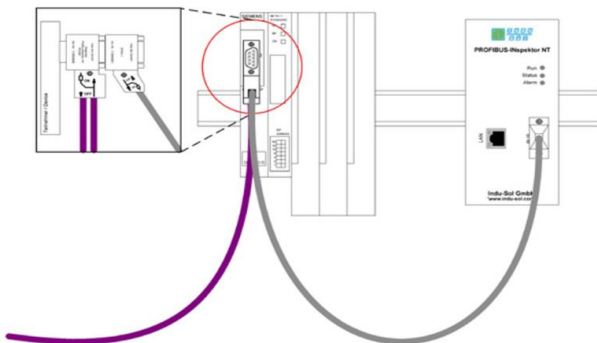
The PB-INspektor® NT diagnostic tool is permanently set up to evaluate the logical communication.

With a help of the PROFIBUS-INspektor® NT tool, the diagnostic messages in a time window of minimum one hour, Utthunga PI certified network experts analyzed the existing condition of the plant network along with real time data transmission.

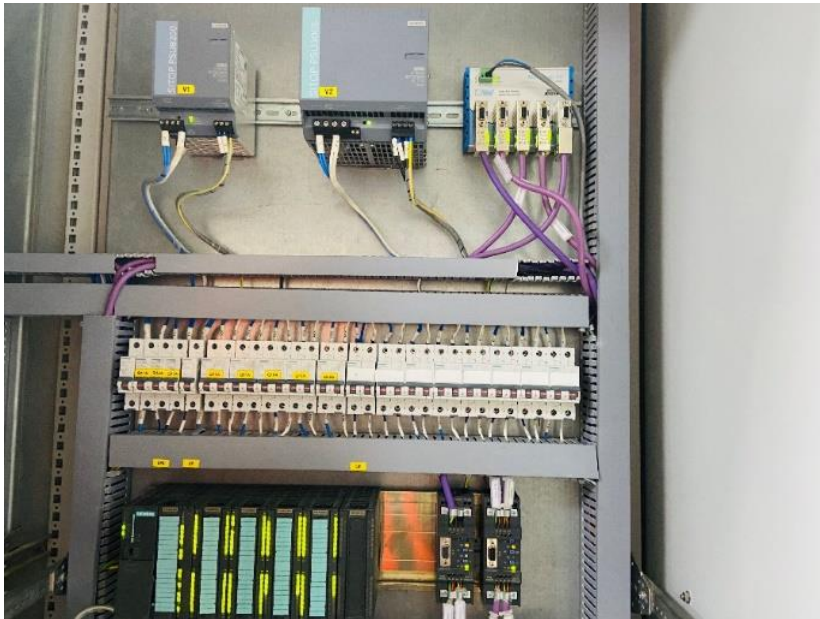
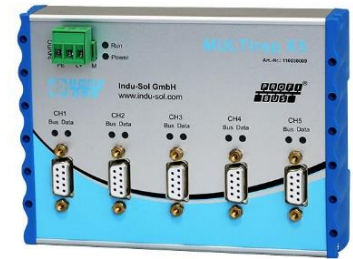
Figure-3: Five (5) channel repeater installed in the packaging line

Multirep-X5 – 5 channel repeater

Utthunga recommended AB InBev to put Indu-Sol's MULTirep X5 Repeater (5 channel) in between the network for proper PROFIBUS segmentation. Utthunga demonstrated a test run using the repeater which prompted a change in the architecture. After using the repeaters to split the network to four segments, the communication voltage (signal quality) of PROFIBUS network was enhanced. The diagram below shows the X5 repeater (5 channel) installed in the line.

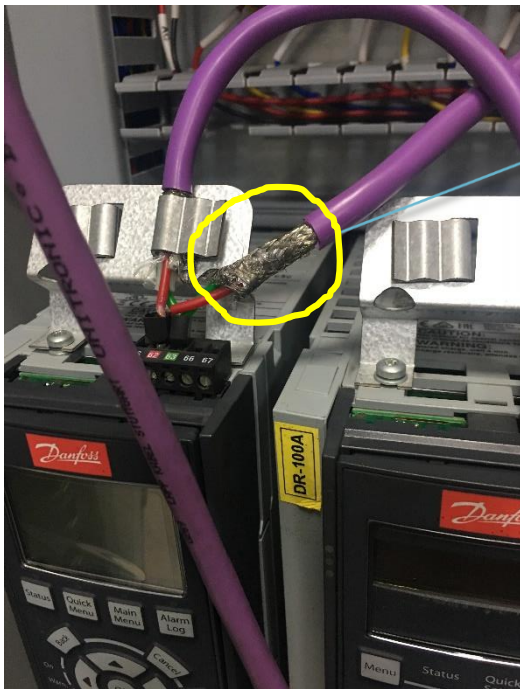
Shielding done in the VFD was not as per standards.

This lead to leakage of current, which in turn affected the bit transition in PROFIBUS communication hence leading to intermittent failures.

Figures - 7 & 8: Improper shielding noted and rectified by the Utthunga PROFIBUS network experts

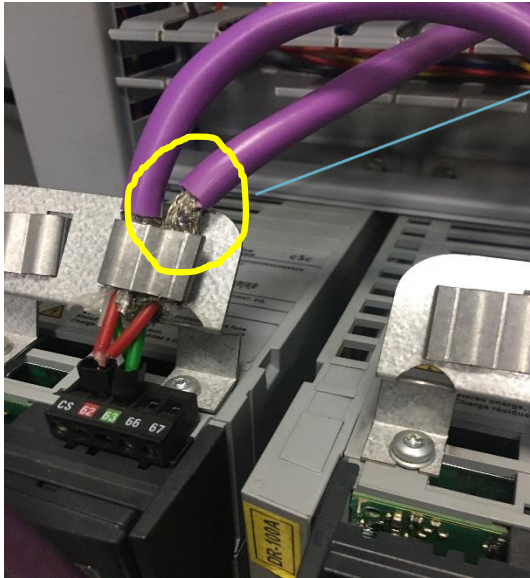
Shielding in the VFD made as per standards.

Proper grounding avoids harmonics in the PROFIBUS communication which in-turn helps in the stability and health of the communication.
